EVALUATION AND UPDATING OF OFFSHORE BASE MAPS
USING SPOT SATELLITE IMAGES AND GPS CONTROL, WEST AFRICA *

Peter B. Goodwin, Pat D. Caldwell, and James M. Ellis
Chevron Overseas Petroleum Inc.
San Ramon, California U.S.A

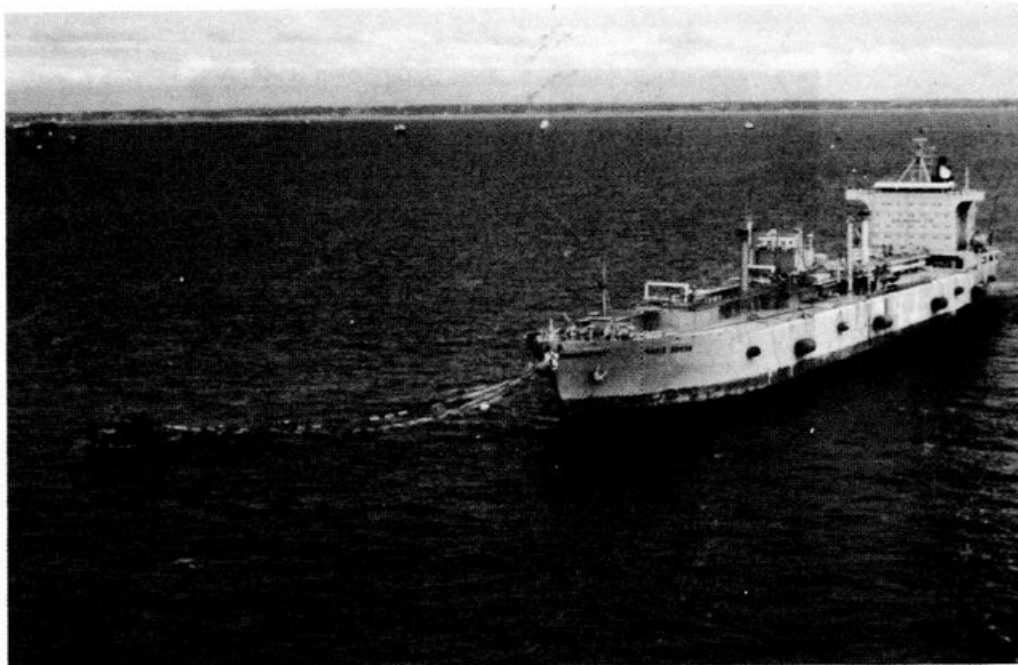
Figure 4. (A) Tanker moored to offshore buoy. View looking toward shore. In background, collection platform (extreme left), risers and flare can be discerned. (B) Moored tanker as seen with SPOT. Ship's bow points toward lower left corner with buoy (?) in lowermost left corner. Superstructure on tanker (see arrow) is brighter than rest of deck. Probable riser visible toward upper right corner. Each pixel represents 10 meters.

Over 110 petroleum-related structures were detected on a single SPOT image (Figure 1) that encompassed 5 offshore production fields. Figures 4, 5 and 6 compare aerial photographs with an enhanced SPOT image of several offshore features (moored tanker, collection platform with helipad, and risers). SPOT imagery allowed differentiation of the superstructure from the main deck on tankers and record individual platforms that were connected with walkways and nested piping.

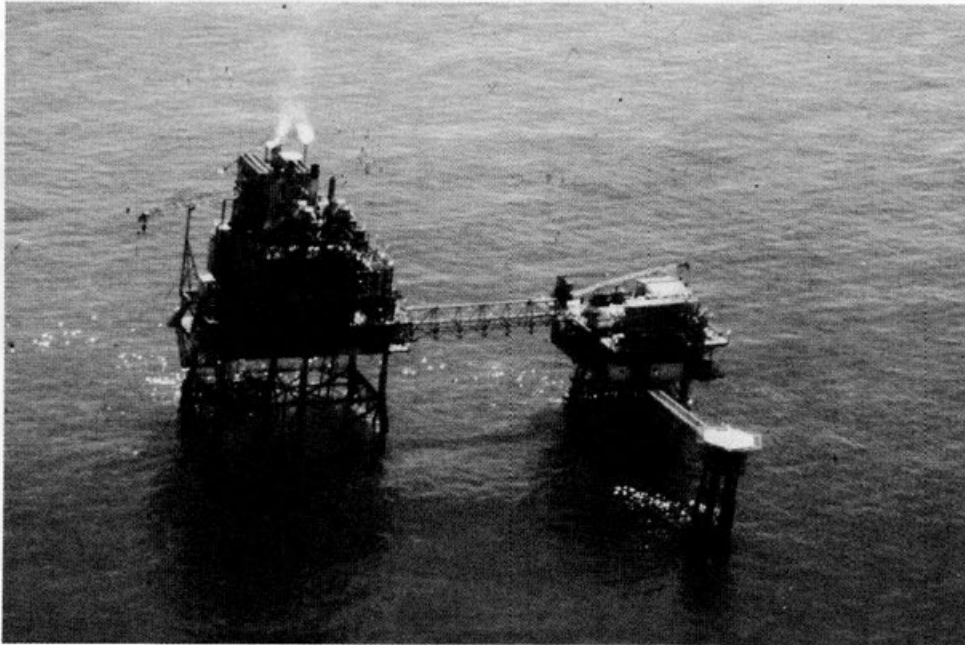
Figure 5. (A) Aerial view of offshore collection platform and (B) same type of structure as seen on SPOT. Shape and components of collection platform can be discerned.

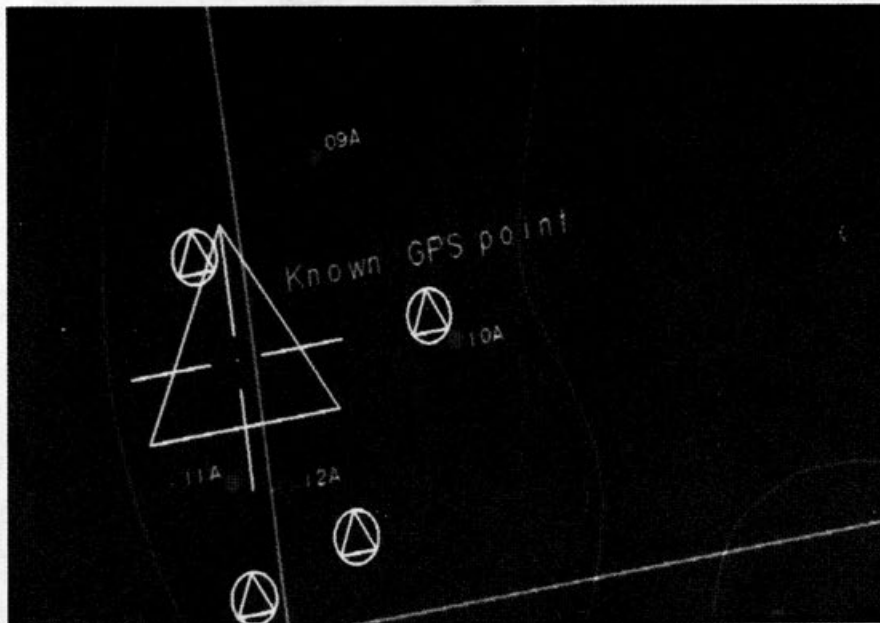
Figure 9. Example of a rasterized CAD map file showing known GPS point, wells in original map base (gray dots), field outline, and new offshore structures seen on SPOT (circles with inscribed triangles).

The GPS fix was digitally transferred in the rasterized CAD file as a dot centered between crosshairs and a triangle (Figure 9). The pixel that contained the fix's location on the SPOT image was registered to the dot in the center of the CAD symbol (Figure 10). After at least 6 control points were registered between the image and CAD map (usually a few from onshore and the rest from large, offshore collection platforms), the image was "warped" to the GPS control, which placed the image into the company's CAD base map projection.

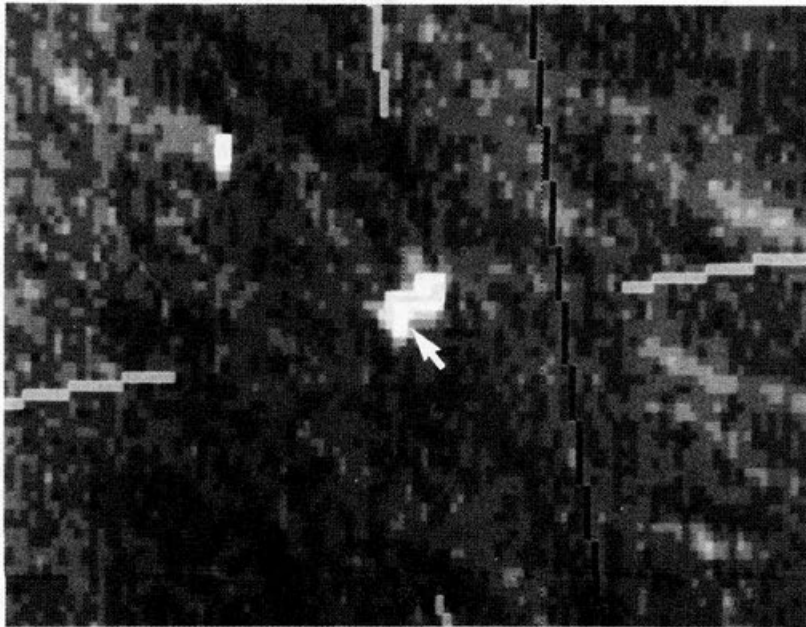
Figure 12. Close-up showing GPS fix (tip of arrow) on the collection platform. From the surveyor's plat (Figure 8) the fix was located on the SE corner of the most southern structure.

Individual SPOT images were digitally rectified to a country's standard map projection using at least 6 Global Positioning Satellite (GPS) fixes. These fixes were initially loaded into our computer-aided drafting (CAD) system and digitally transferred as a raster map file to our image processing system. Registration of offshore structures (as seen on the SPOT image) with the correct GPS fixes was done within the image processing system (Figures 7 through 12).
