# GeoTechnologies Facilitate Geologic Mapping and Field Operations in Colombia

## REMOTE SENSING TECHNOLOGY FOR GEOLOGIC MAPPING AND FIELD OPERATIONS, COLOMBIA\*

J.M. Ellis, W. Narr, and P.B. Goodwin  
Chevron Overseas Petroleum Inc.  
San Ramon, California

### **ABSTRACT**

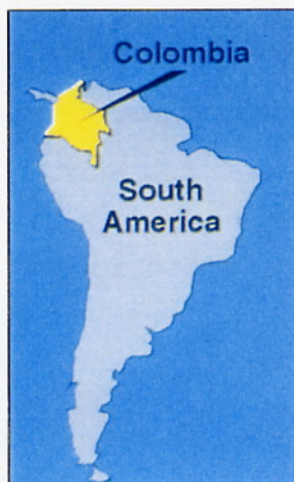
A geologic map illustrating the major tectonics of Colombia. The areas of recent petroleum activity are along the flanks of the Eastern Cordillera. Sumapaz is located along the west flank, and Rio Blanco is on the east.

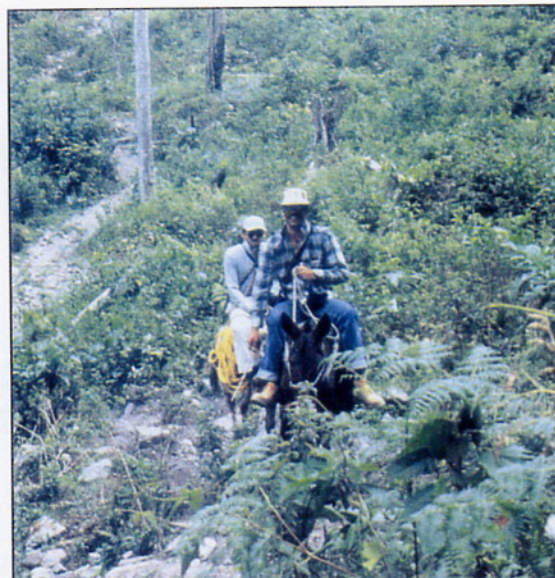
**Above: Field work is still necessary, but, as Mr. Perez found out, it is easier, with less time "in the saddle" when organized with remote sensing. Below: Geologic map constructed from aerial SAR, satellite remote sensing, and field work. Note the thrust faults and outcrop patterns which are not visible on the original map.**

Several iterations of field mapping, reinterpretation of Landsat, SAR, and aerial photographs, and redrafting resulted in a final 1:50,000 geologic scale map of Sumapaz. The amount of redrafting was substantial as overlays at 2 scales were utilized by several earth scientists for geologic interpretation during the project. This procedure led to a very high error rate that required a substantial effort to repair. However, compared to one of the published maps available at the beginning of this Sumapaz mapping project (Figure 11), the new geologic map generated from this integrated project was more accurate and useful for supporting exploration (Figure 12).
